Performance of a 60-year-old concrete pier with stainless steel reinforcement

A 60-year-old concrete pier, constructed with stainless steel reinforcing bars (rebar) and exposed to a tropical marine environment, has shown good performance during its service life. This article describes the tests carried out on the pier during this investigation. The tests included visual inspection, chloride content determination, and concrete resistivity as well as electrochemical measurements to the rebar. The authors also discuss durability issues on the pier, based on the results obtained.

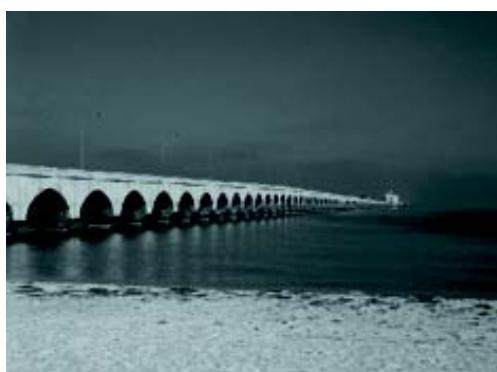
FIGURE 1
General view of the Progreso pier.

The pier shows no visible sign of deterioration after 60 years of service,

even though the structure has received no maintenance during this period of time, according to port authorities.²

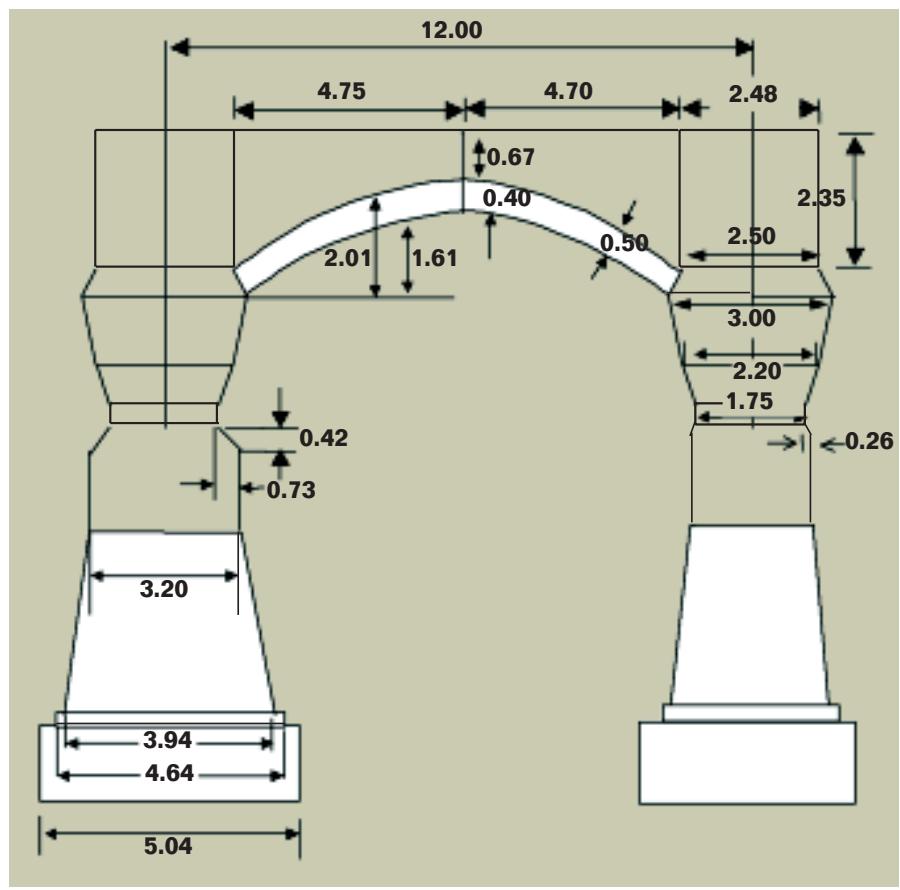
FIGURE 2

The pier (1,752 m long and 9.5 m wide) consists of 146 hinged arches 12-m center-to-center span and 1.6-m high (Figure 2). Each arch is supported at the ends by reinforced concrete girders, each resting on two massive concrete piles. One of the reasons why this design was selected was to eliminate conventional carbon steel reinforcing bars (rebar) by using massive concrete in the substructure. The Mexican authorities wanted to build this pier having low or no corrosion risk, thus avoiding the severe corrosion problems that had developed in several other marine structures in Mexico. This innovative project utilized type 304 stainless steel (SS) (UNS S30400) for girder reinforcement and, in the long term, for corrosion protection. To do so, 220 tons (199,584 kg) of 30-mm-diameter SS, nondeformed bars were used.¹

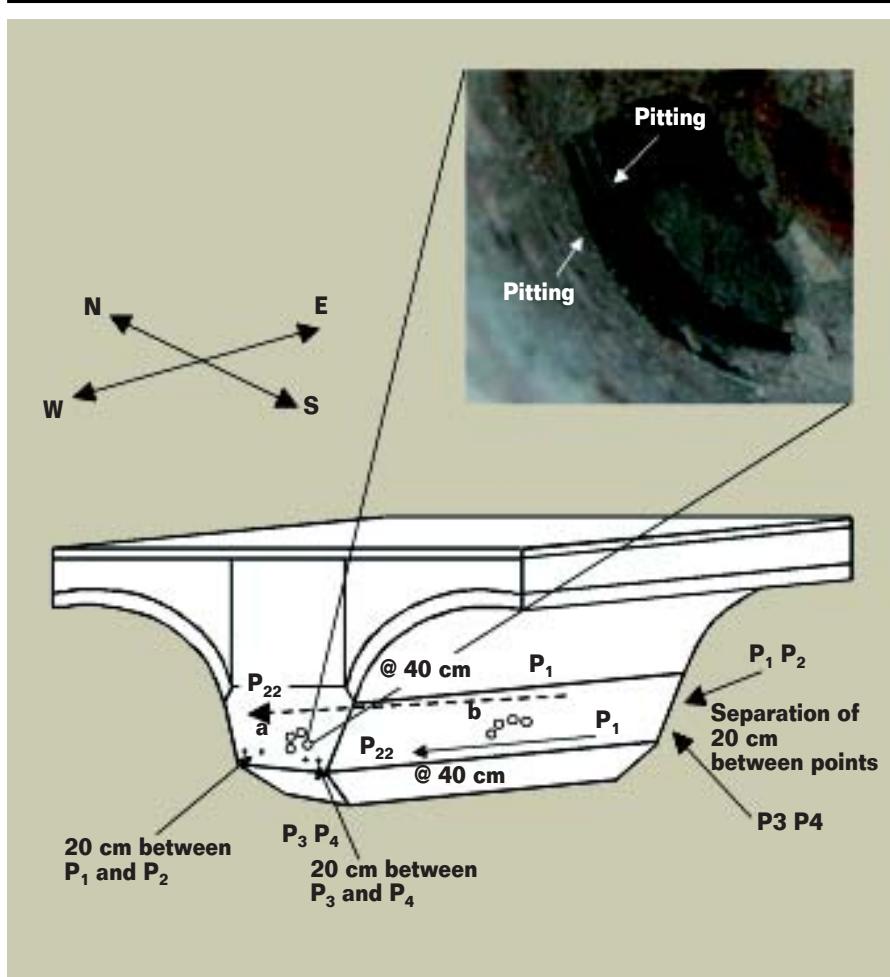
FIGURE 3

Location of the core extractions and electrochemical measurements on the pier.

In order to verify the validity of the E_{corr} and I_{corr} measurements, the researchers obtained concrete cores from the area above the exposed SS bar. These cores helped to confirm the position of the SS bar inside the girder and the surface condition of the unexposed metal. Figure 3 shows the locations of the extracted cores. The insert

shows a small part of the embedded SS bar surface condition exposed after concrete core drilling. A few rusty spots were observed and identified as pitting.

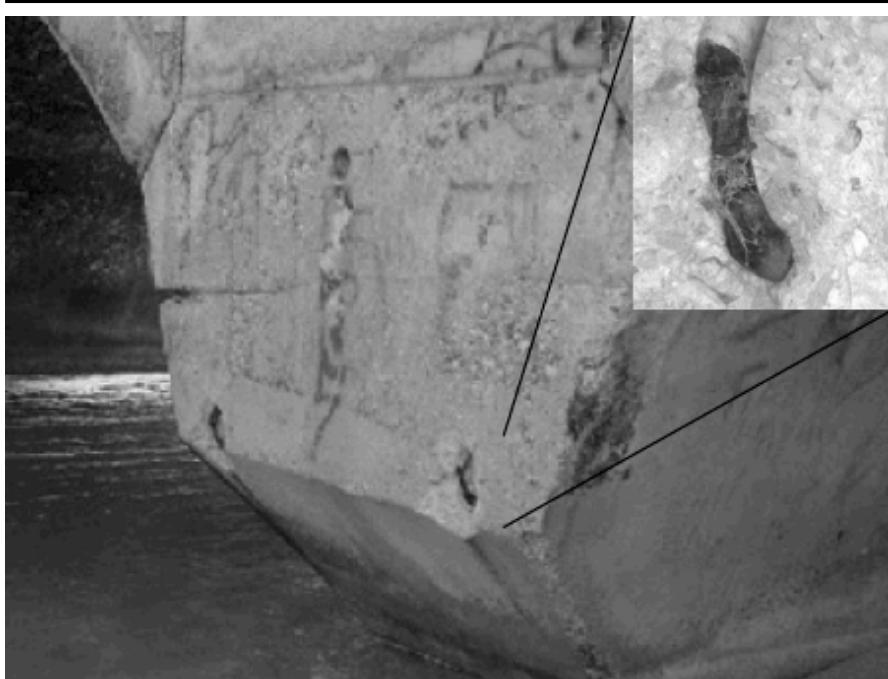
FIGURE 4

According to a previous report regarding this pier,¹⁰ SS bars were directly exposed in the west face of girder No. 9 because of insufficient concrete cover (<1 cm). Because these portions of reinforcement belong to the bended part of end hooks, stress corrosion cracking (SCC) has affected these areas (Figure 4). The SCC was also evaluated in this investigation. At this time, it is unclear whether SCC was an initial or subsequent event: either the chloride ion caused SCC in the embedded steel and then the loss of the concrete cover or the steel was first ex-

posed (because of the low concrete cover) and then SCC occurred. By comparing the results from reference (4) with the visual inspection reported here, it is clear that after 3 years the corrosion of the reinforcement has not significantly worsened.

Very severe localized corrosion was observed on the top of an SS rebar located in the east face, however. This rebar was exposed after the previous investigation (December 1998), and it is located in a vertical position with 3 cm of concrete cover. Corrosion was not observed on the bottom of the rebar, where the seawater from the marine breeze tends to accumulate, thereby creating an ideal place for the initiation of corrosion.

Girder No. 9, where most of the tests were performed. SCC occurred on rebar exposed at this girder.

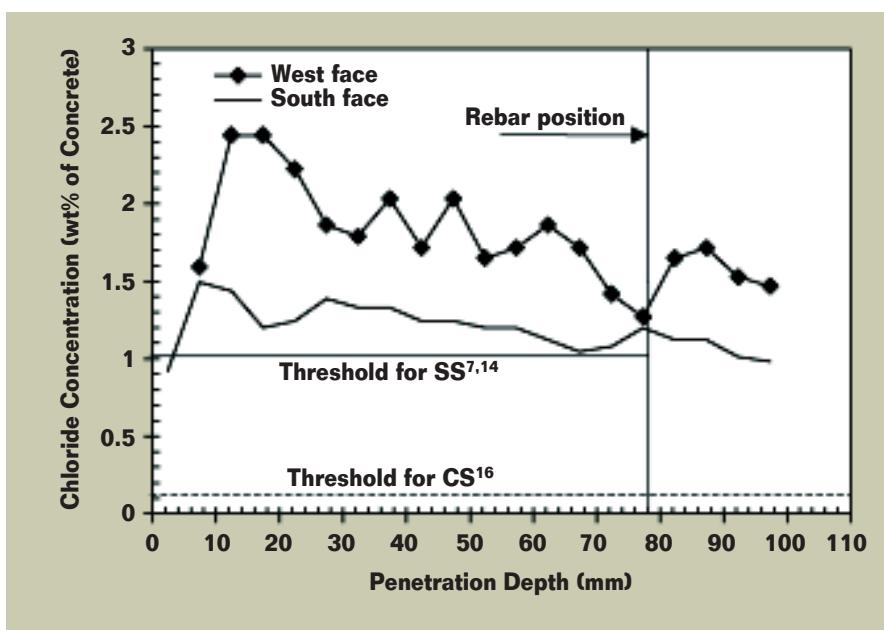
FIGURE 5

Figure 5 shows the chloride profile concentrations obtained from two different cores, one extracted from the west face and the other from the south face. The chloride concentrations at the rebar depth obtained in this investigation are in agreement with those obtained in the previous survey.¹⁰ The maximum chloride concentration ob-

The chloride threshold for AISI 304 was estimated to be between 0.7 and 1 wt% of concrete.¹³⁻¹⁴ According to the chloride profiles obtained for the evaluated girder (Figure 5), the chloride content measured at the rebar depth (~1.2 wt% of dry concrete) is above the chloride threshold reported for this type of rebar. However, a higher chloride threshold for AISI 316 and AISI 316 clad bars has been reported elsewhere.^{7,13}

The previous results regarding E_{corr}, I_{corr}, and chloride content at the bar depth confirm that the SS rebar at girder No. 9 is in the process of active corrosion. This situation demands a fur-

Chloride concentration profiles in girder No. 9.

ther analysis to corroborate—by means of a more extensive and systematic study—if other girders beyond the shoreline are also experiencing corrosion degradation.¹⁵
