RDT 03-003

Evaluation of Stainless Steel Reinforcement Construction Report

RI 00-027

**Evaluation Of Stainless Steel Reinforcement
Construction Report**

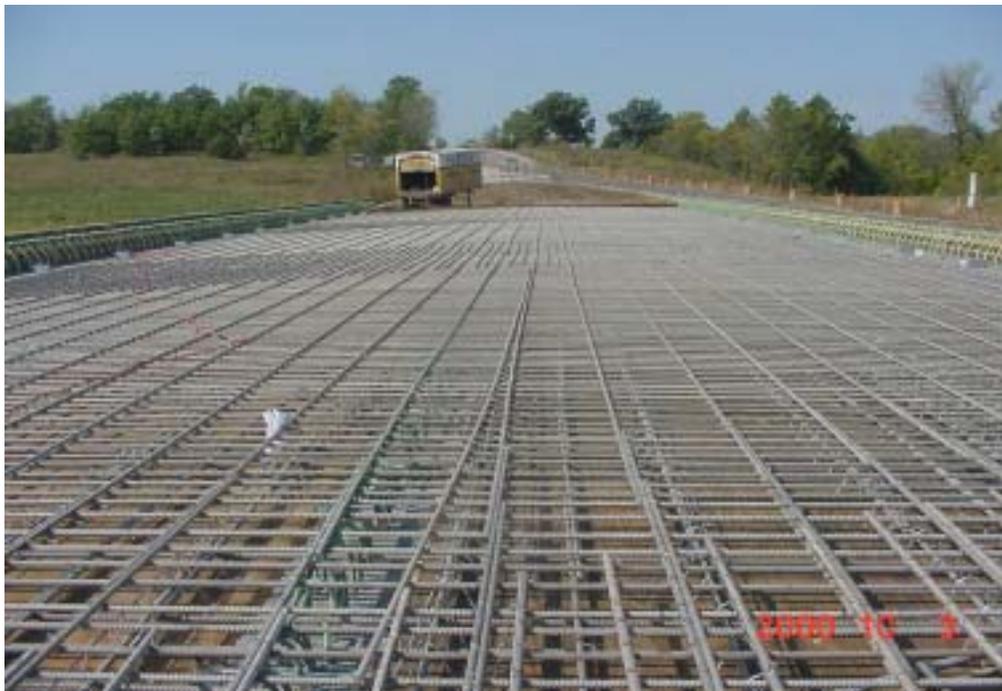
Figure 1. Stainless Steel Reinforcement of Bridge A6059

The only difficulty in placing the stainless steel rebar was at splices to black rebar needed at the solid diaphragms, at the abutment and pier caps. Specifications called for using 1" plastic spacers so there would be no reaction between the two dissimilar metals. The rebar could not be firmly fastened in this way, and the contractor installed additional epoxy coated rebar so that both the black and stainless steel rebar could be attached to the epoxy without touching each other. This problem will be fixed in the next project, described below, in which all the conventional rebar spliced to stainless steel clad rebar will be designed to be epoxy coated.

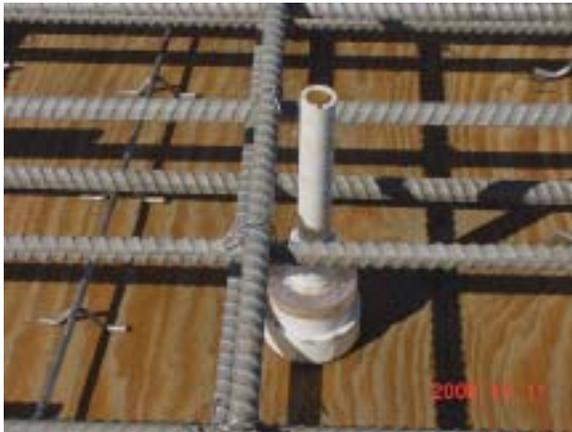
Figure 2. Sensor Housing Attached to Forms of CIP Deck

In this project, non-destructive fiber optic chloride testing will be performed on both the experimental and control bridge decks. Fiber optic chloride sensors were incorporated into both bridge decks. 20 sensors were set on each bridge at different horizons. Before the sensors were put in, the sensor housings were installed during the deck construction. See Figure 2, 3 for the installation of sensor housings, and Figure 4, 5, 6 and 7 for their horizontal locations and depths. The most popular sensor openings are set at ½", 1 ½" and 3" (rebar level) from the top of the deck. The sensor housings were literally nailed to the bottom formwork. On bridge A6060, the conventional construction using epoxy rebar, prestressed precast deck panels were used instead of forming. Holes had to be cored to allow installation of four (4) of the chloride sensor housings. After measuring to make sure none of the prestressing strands would be cut, 2" diameter holes were cored in the 4" thick panels. Epoxy glue was used to hold the sensor housings in place. The remaining six (6) sensor housings were set on each side of the bridge where they could be nailed into the conventional forming needed on the overhangs. After the concrete was cured, and formwork was removed, the nails sticking through the bottom PVC cap of the sensor housing protruded from the concrete. With the assistance of ladders to reach the deck bottom, these housing caps were unscrewed on June 28, 2001 to remove the steel and plastic bars which kept concrete out of the throat area of the housings. Since the old caps were damaged during the unscrewing, new caps were screwed back onto the housings.

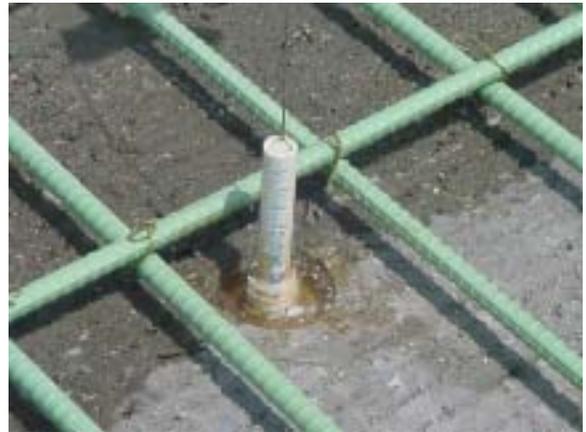
Figure 3. Sensor Housing Glued into Deck Panel Core Hole

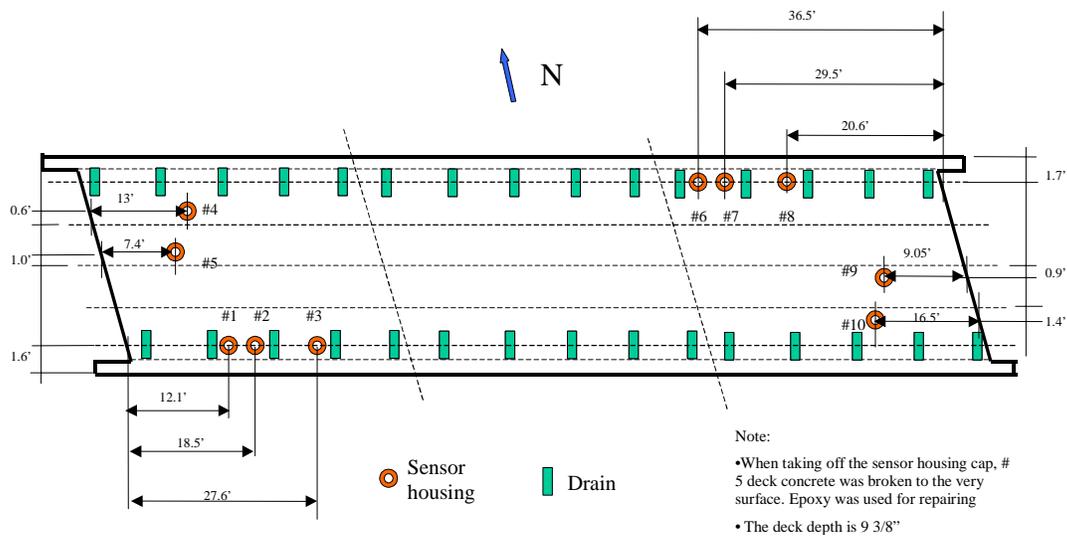
Figure 4. Locations of Sensor Housings of Stainless Steel Bridge A6059

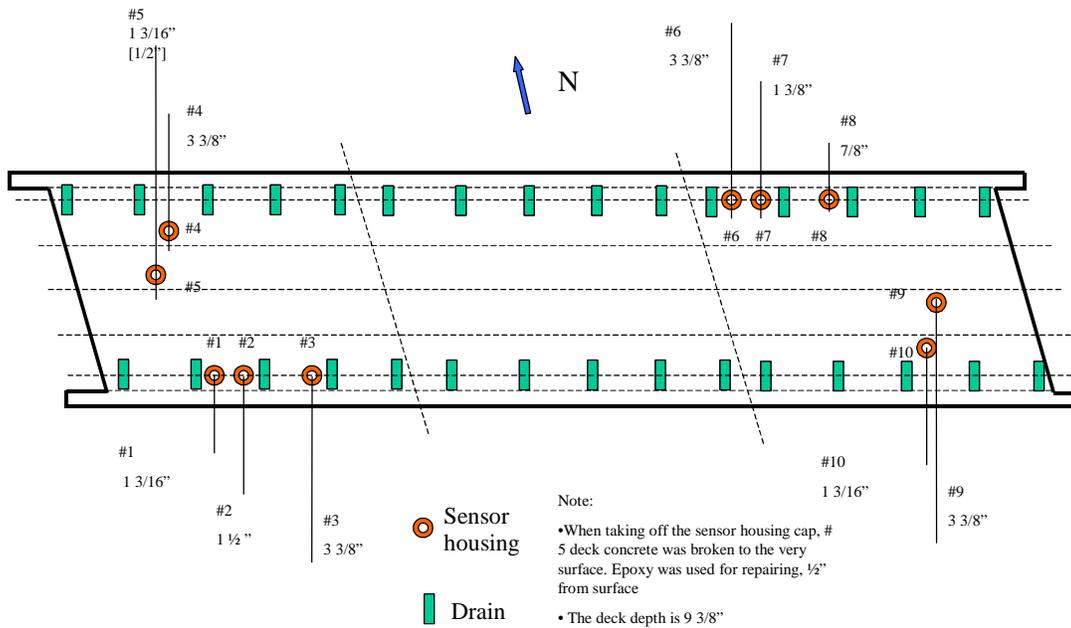
Figure 5. Depths of Sensor Housings of Stainless Steel Bridge A6059

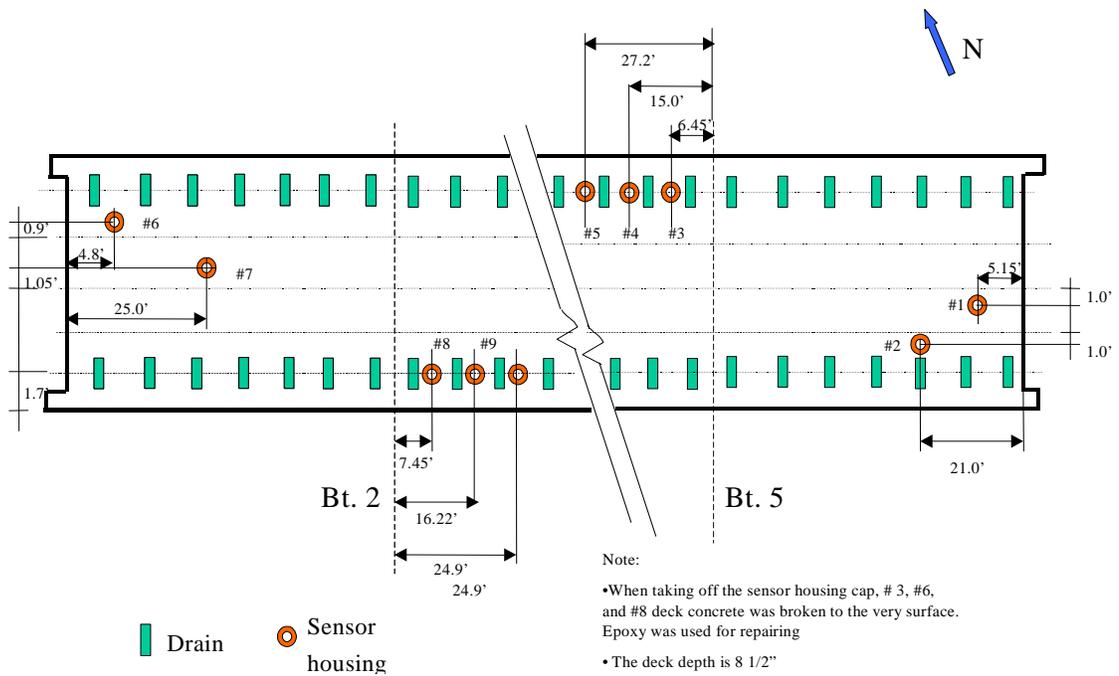
Figure 6. Locations of Sensor Housings of Epoxy Steel Bridge A6060

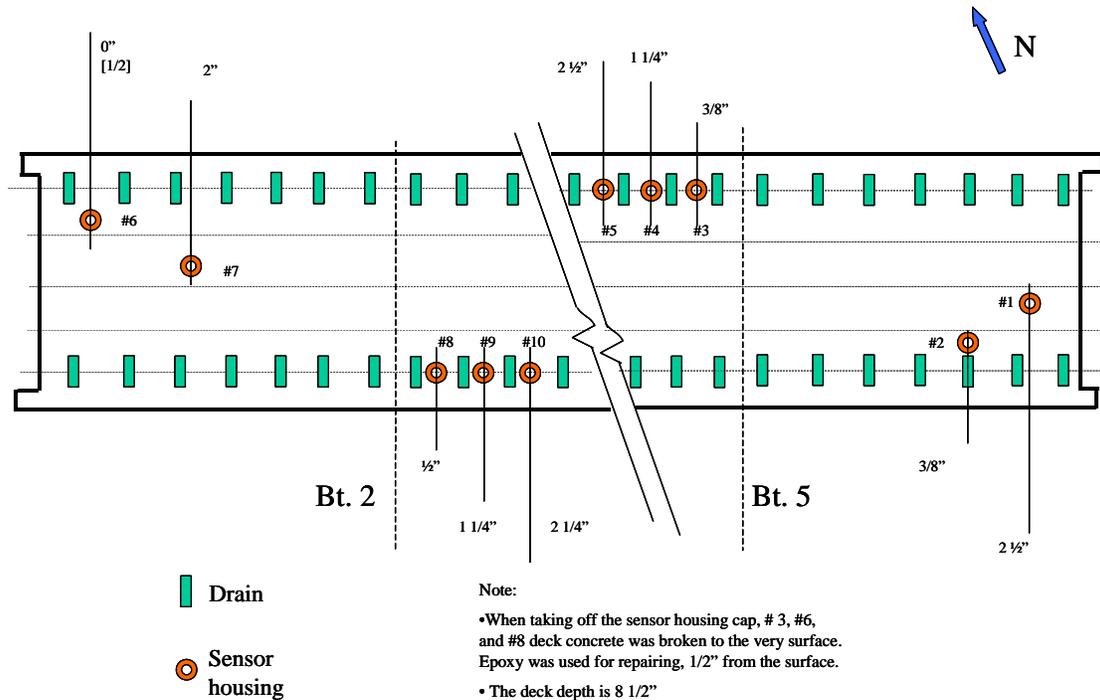
Figure 7. Sensor Housing Depths of Epoxy Bridge A6060

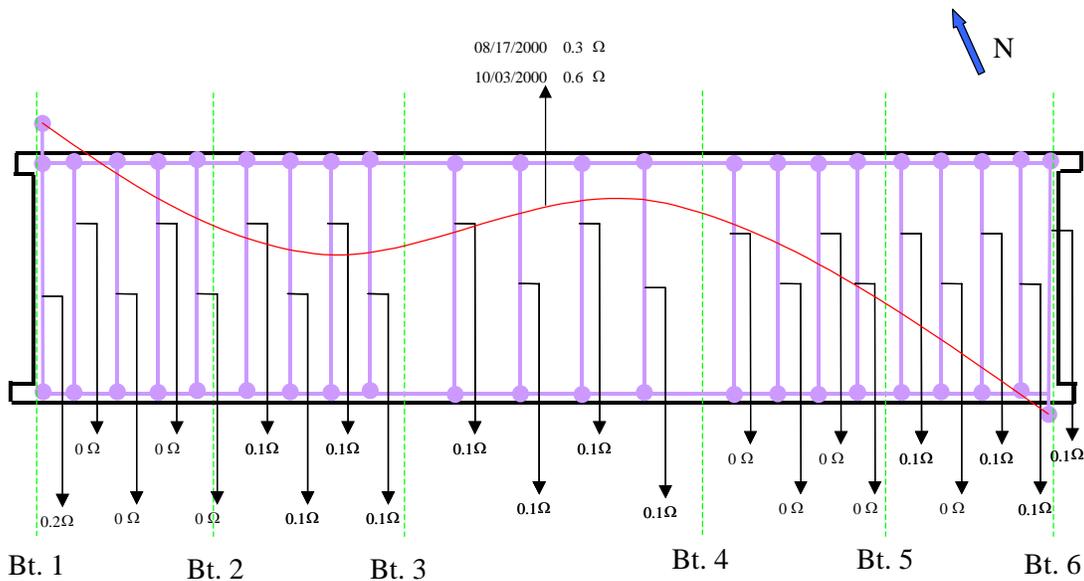
In order to use AC impedance testing on the epoxy coated reinforcement, a test grid was set up with 22 bars made electrically continuous and a bar at each end of the bridge left protruding from the side of the deck for an electrical connection. Continuity tests were done on August 17, 2000 before the deck pour and on October 3, 2000 after the deck pour. Resistance readings of each circuit are shown on Figure 6.

Figure 8. Continuity Test of Bridge A6060

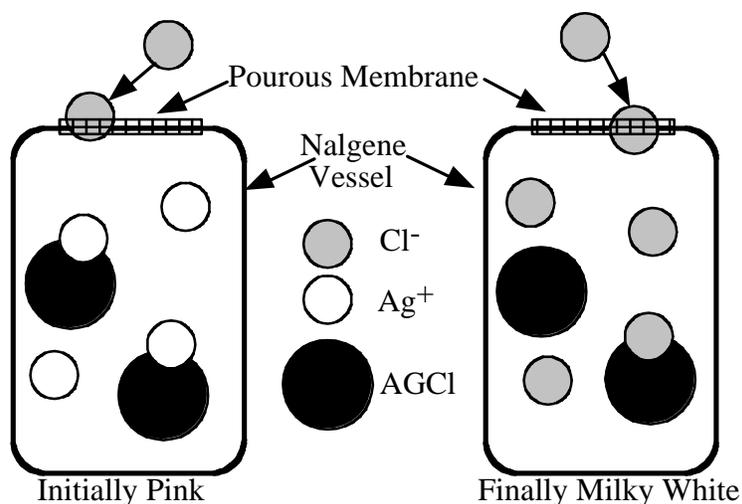
spectroscopy using fibers for delivery and reception of the light from the sensing unit and Fajans method of chloride analysis. The result is a fiber optic sensor that measures chloride concentration. Such a fiber optic sensor is based on the optical absorption of a broadband input signal through a silver nitrate solution. The sensor head consists of a Nalgene tee chamber into which an indicator solution is placed, a porous membrane on top, and fiber optic leads. Upon introducing this sensor to an aqueous environment containing chloride, the chloride will migrate through the porous membrane to the silver nitrate solution. The chloride ions bond with the silver ions to form silver chloride. There exists an excess of positive silver ions that adsorb onto the silver chloride molecule surface resulting in a net positive charge. Because the indicator, dichlorofluorescein, is an anionic dye, it is attracted to the precipitate resulting in a pink color. As observed in Figure 1, as more chloride passes through the membrane, eventually chloride ions outnumber the silver ions. Chloride ions adsorb onto the surface of the silver chloride molecule resulting in a net negative charge, repelling the dichlorofluorescein indicator. The precipitate, at this point, turns from pink to milky white. It is this shift in color from pink to white that indicates the concentration of chloride has exceeded the concentration of silver, which is known.

Figure 1. As the chloride ion concentration increases, the adsorption process causes a chemical reaction within the solution that results in a color variation.

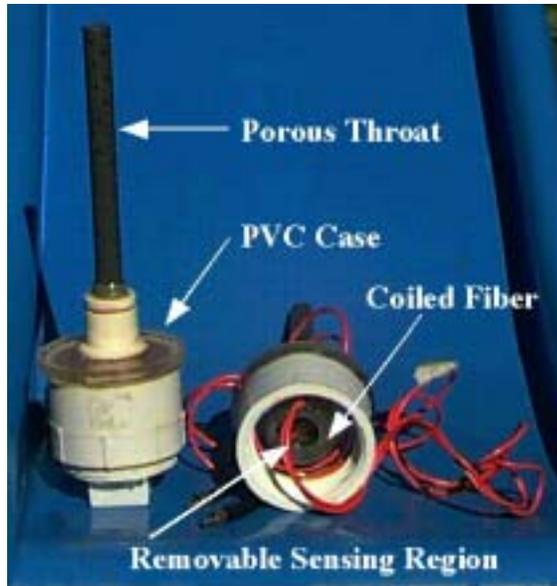
Figure 2. The fibers, reagent chemistry cell, and micro-optics are cast in epoxy into a threaded section that allows this section to be literally screwed into the sensor housing in line with the porous throat's tube section. More details on the sensor design and motivations are presented in the following section.

Figure 2. The final design, suitable for bridge deck installation, is shown.

Ten (10) fiber optic chloride sensors, of the type shown in Figure 2, were embedded at various points along the bridge. Missouri Department of Transportation officials performed placement of the chloride sensors in 2000 with the sensor placement heavily influenced by where the drains would be placed on the bridge deck. Their configuration is such that broadband light is injected into one fiber. At the chloride sensing location, the light must pass through a thin membrane whose transmission properties change with increasing chloride concentration. The change in amplitude and wavelength for the modulated light is then measured from which the chloride concentration may be determined. Access to these sensors is from the bottom of the bridge deck.

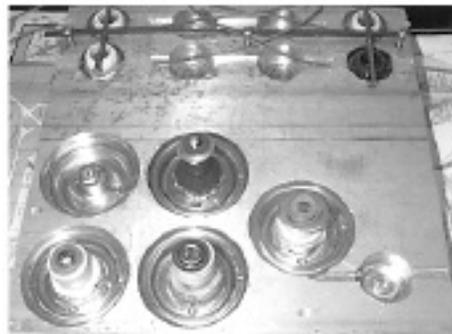
The components comprising this sensor include a number of custom-machined composite pieces. In certain instances, it has proven to be prudent to injection mold the pieces. The master for these pieces, which include the Nalgene chemical reservoirs, are shown in Figure 3.

Figure 3. This machined master component allows for multiple chemical reservoirs to be fabricated simultaneously.

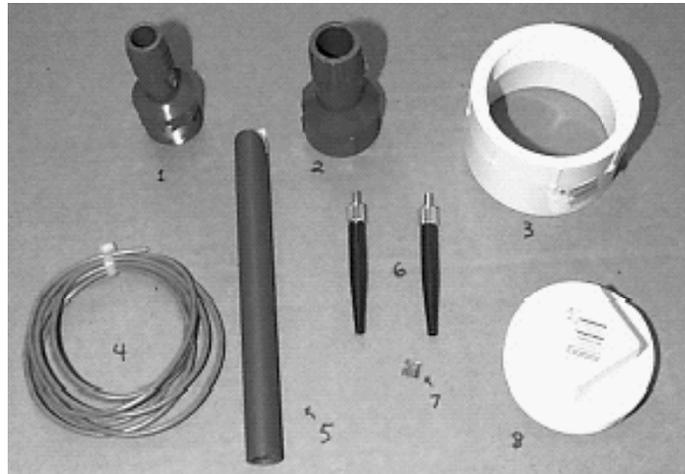
accelerants, for rapid curing, is used, the construction site personnel acknowledge the noninvasive chemistry of PVC into the mixture. Therefore a PVC cylinder with female insert is used for the sensing region housing. Certain components are shown in Figure 4.

Figure 4. This photo shows a few of the components used in the embeddable sensor.

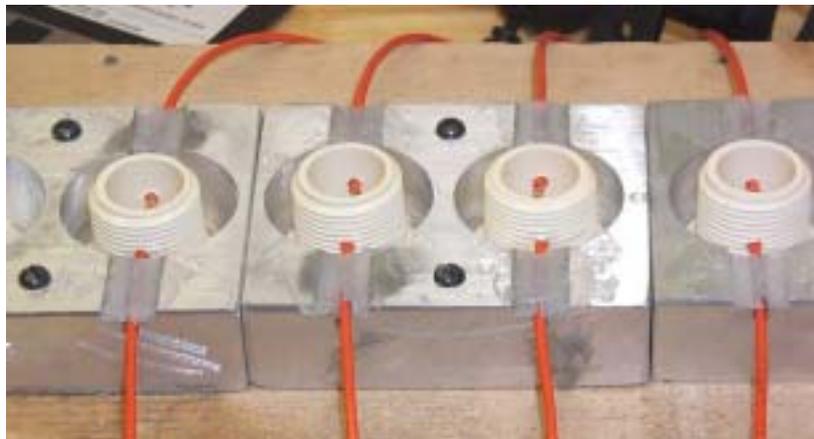
Figure 5. Optical fibers are glued into place and threaded through drilled holes in the PVC screw on cap.

A detailed view of key aspects within the chloride sensor fabrication phase is shown in Figures 5 through 7.

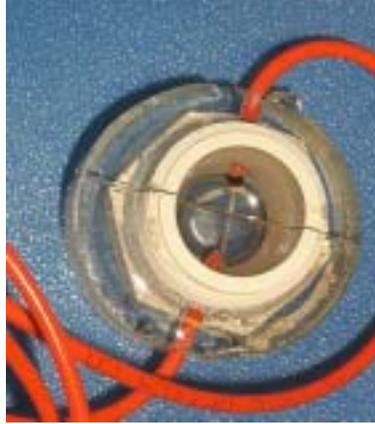
Figure 6. Note that the cap and fiber have been cut. This was achieved using a diamond saw. Into this notch is placed the active chloride sensing element. The fibers act as transmit and receive light pipes.

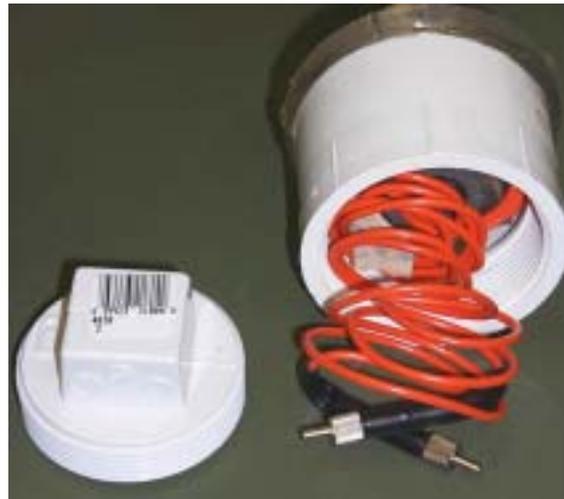
Figure 7. The transmit/receive fibers coil into the base of the sensor unit.

Referring to Figure 7, the sensor housing, or case, is made of 2" stock PVC. A transparent plastic case top is epoxied to the PVC. Through this top extends a hard plastic tube whose length varies according to the placement requirements of the bridge deck (e.g., if the deck is relatively thin then this tube is shorter than if the deck is considerably thicker). The tube has holes drilled throughout it and a wire mesh covering the tube's top opening (to keep aggregate and other materials out of the sensor). Waterborne chloride enters the tube through any of the openings where it falls to the bottom of the tube. There it interacts with the sensor chloride-sensitive reagent. Once the chloride concentration reaches a certain predetermined level a change in the optical transmission characteristics will occur. For these particular bridges, this "minimum activation level" was chosen to be 1ppm of chloride. This sensitivity level is

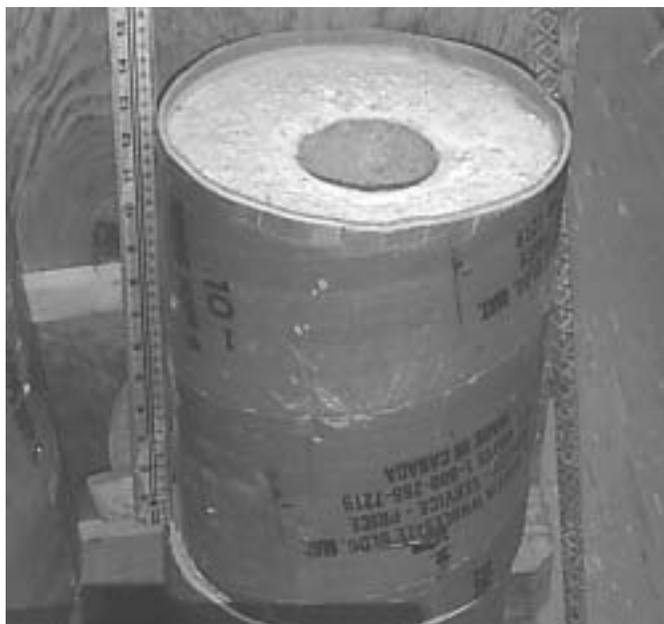
Testing of the sensors' performance after they were embedded into concrete was conducted following ASTM Standard 1202-94 (chloride ion penetration) and the American Association of State Highway and Transportation Officials "Manual for Maintenance Inspection of Bridges". A representative chloride ponding test cylinder into which a fiber optic chloride sensor was embedded is shown in Figure 8. By replicating prior ASTM testing methods (McPadden, 1997), results indicated that the embedded fiber optic sensor was able to accurately establish the presence of chloride traveling within this test cylinder.

Figure 8. This test cylinder allows ponding of chloride ions in solution. The ions then propagate through the cylinder eventually reaching the fiber optic chloride sensor.

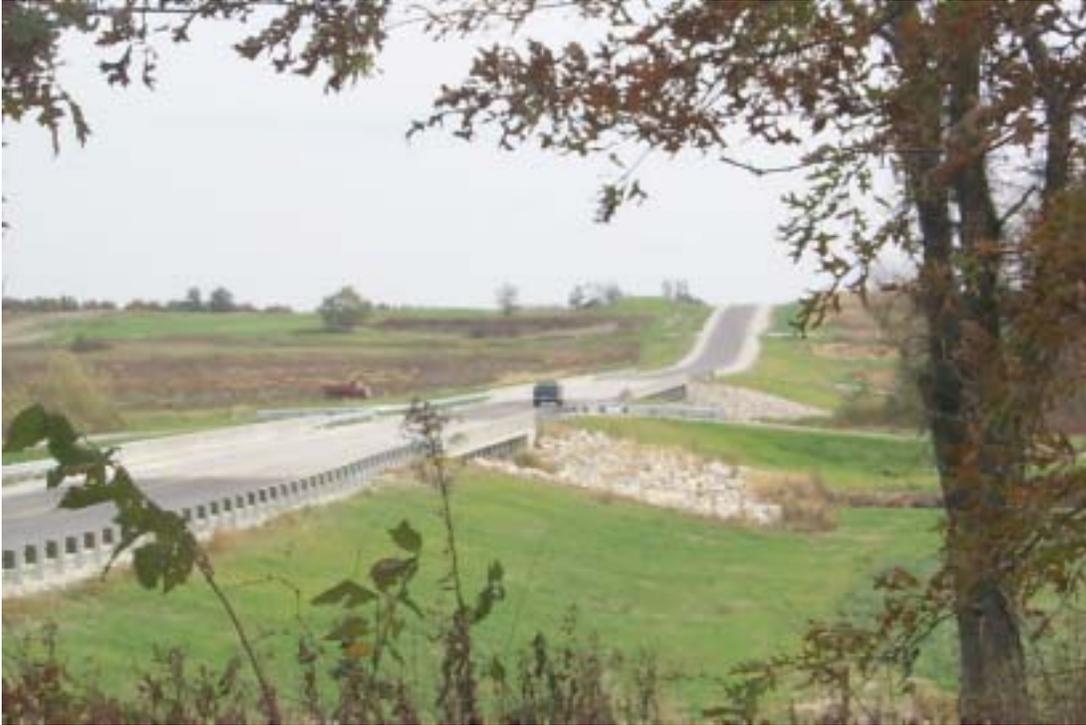
Figure 9. View of the twin State Highway 6 bridges located near Galt, Missouri.

Details of the two bridges located in north-central Missouri on State Highway 6 near Galt, Missouri are to be provided by Missouri Department of Transportation officials. A photograph of the bridges is shown in Figure 9.

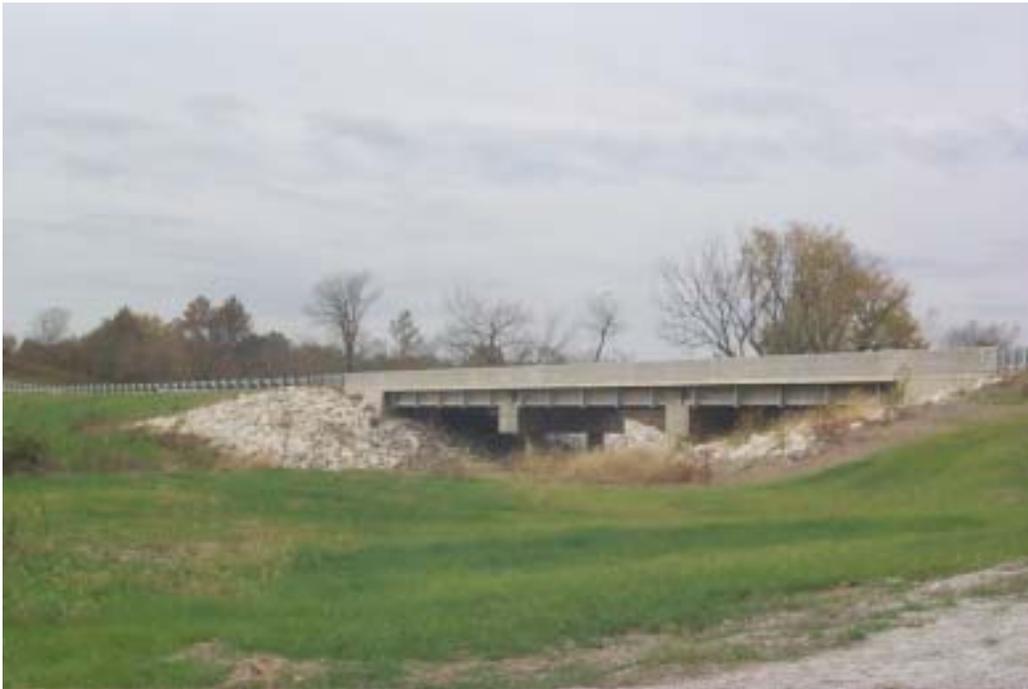
Figure 10.a. Photograph of Bridge #1.

Fiber optic chloride sensors were embedded into two roadway bridges. The bridges were chosen by the Missouri Department of Transportation as representative bridges which having medium levels of deicing agents applied to them each year. The bridges, shown in Figures 10.a and 10.b, are sequential on State Highway 6 and span Medicine Creek and an adjoining field runoff stream near Galt, Missouri. Each structure was built during 2000 at which time the chloride sensor housings were embedded into the reinforced concrete deck.

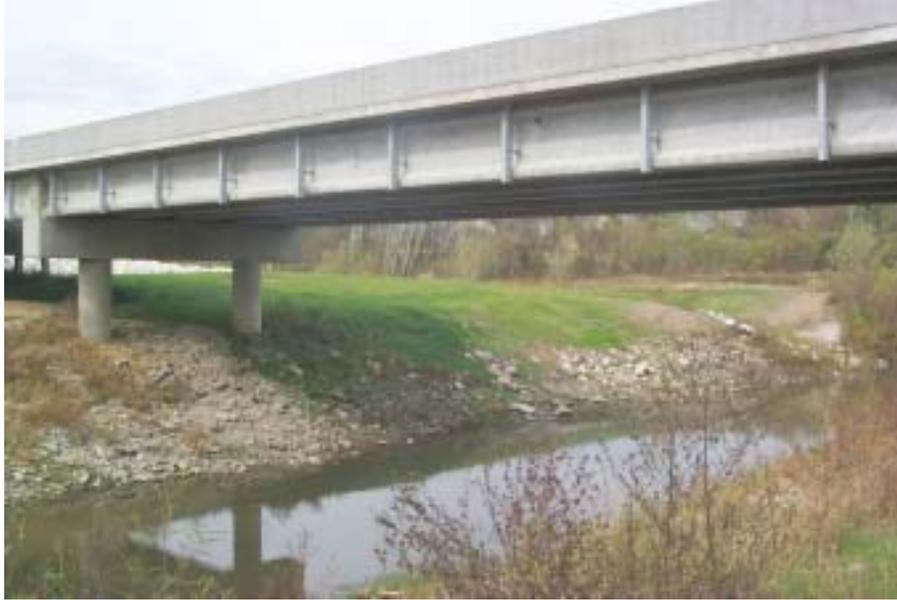
Figure 10.b. Photograph of Bridge #2.

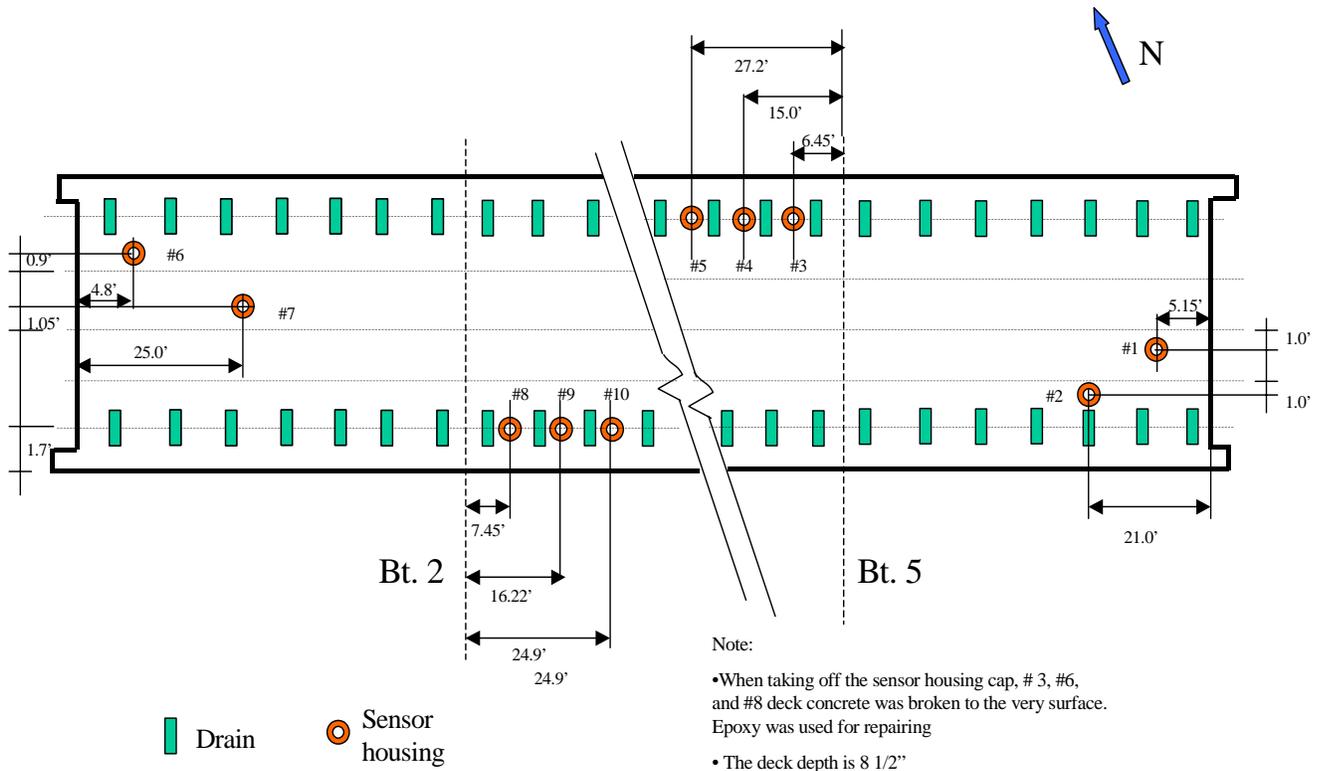
Locations of Sensor housings Epoxy Steel & Deck-Panel Bridge, A 6060

Figure 10.a. Placement of the fiber optic chloride sensors within bridge number A6060.

The locations of the fiber optic chloride sensors that have been embedded into both bridges are shown in Figure 10.

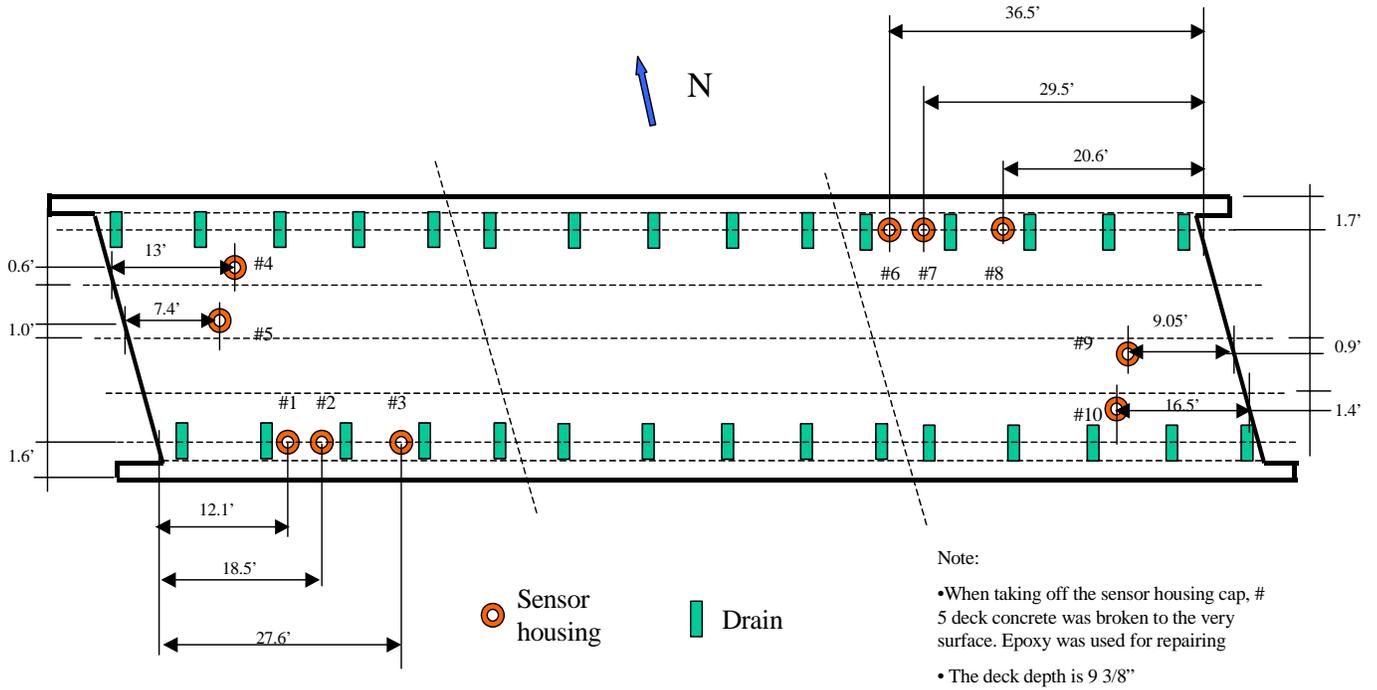
Locations of Sensor Housings

Figure 10.b. Placement of the fiber optic chloride sensors within bridge number A6059.

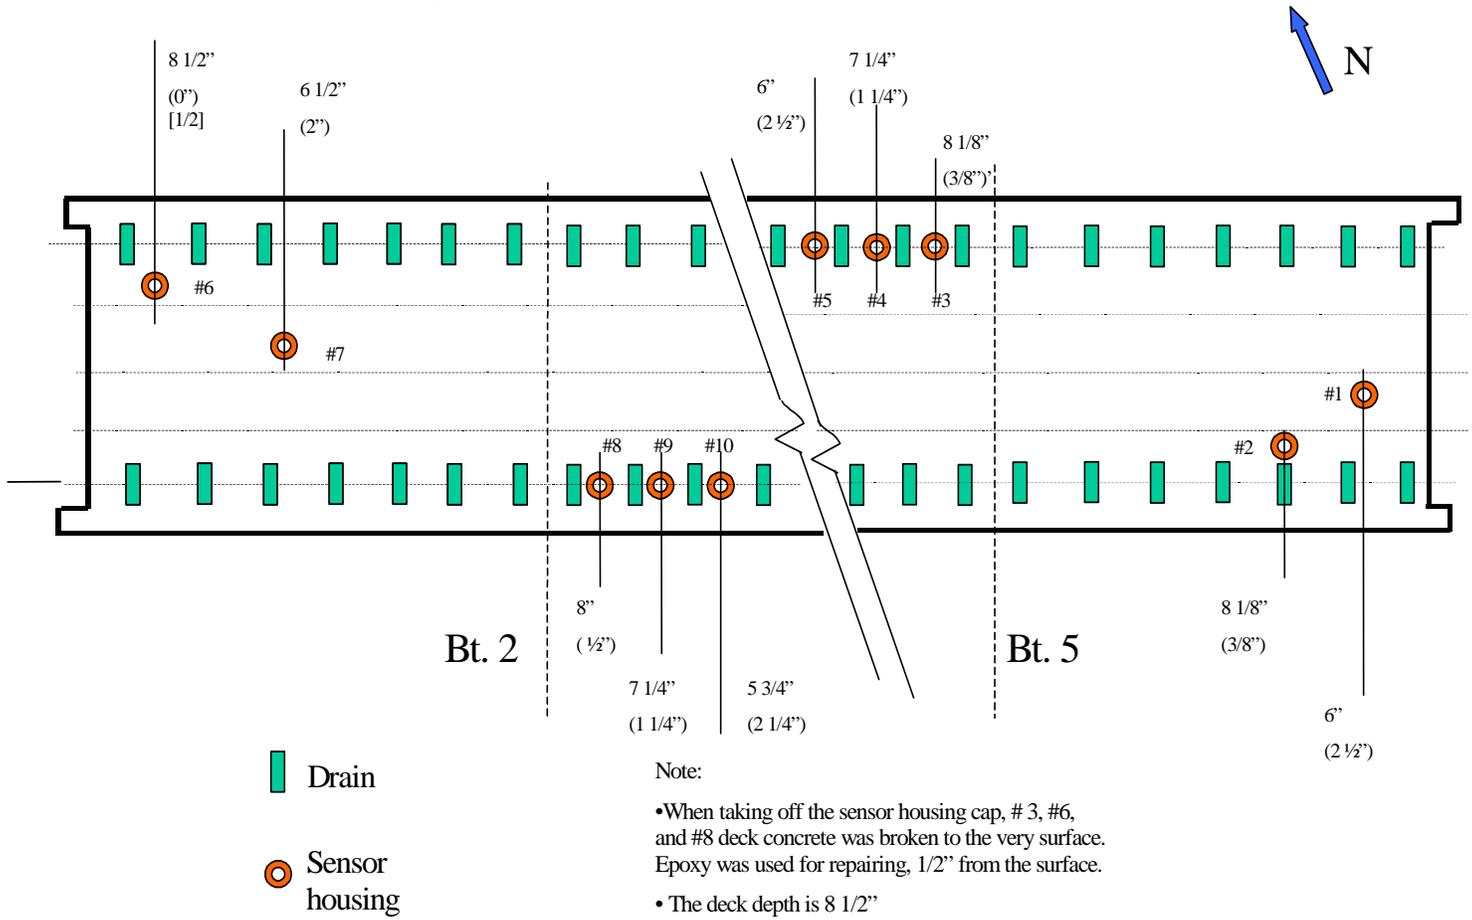
Depths of Sensor Housings

Figure 10.c. The depth of each sensor housing throat is shown for bridge number A6060.

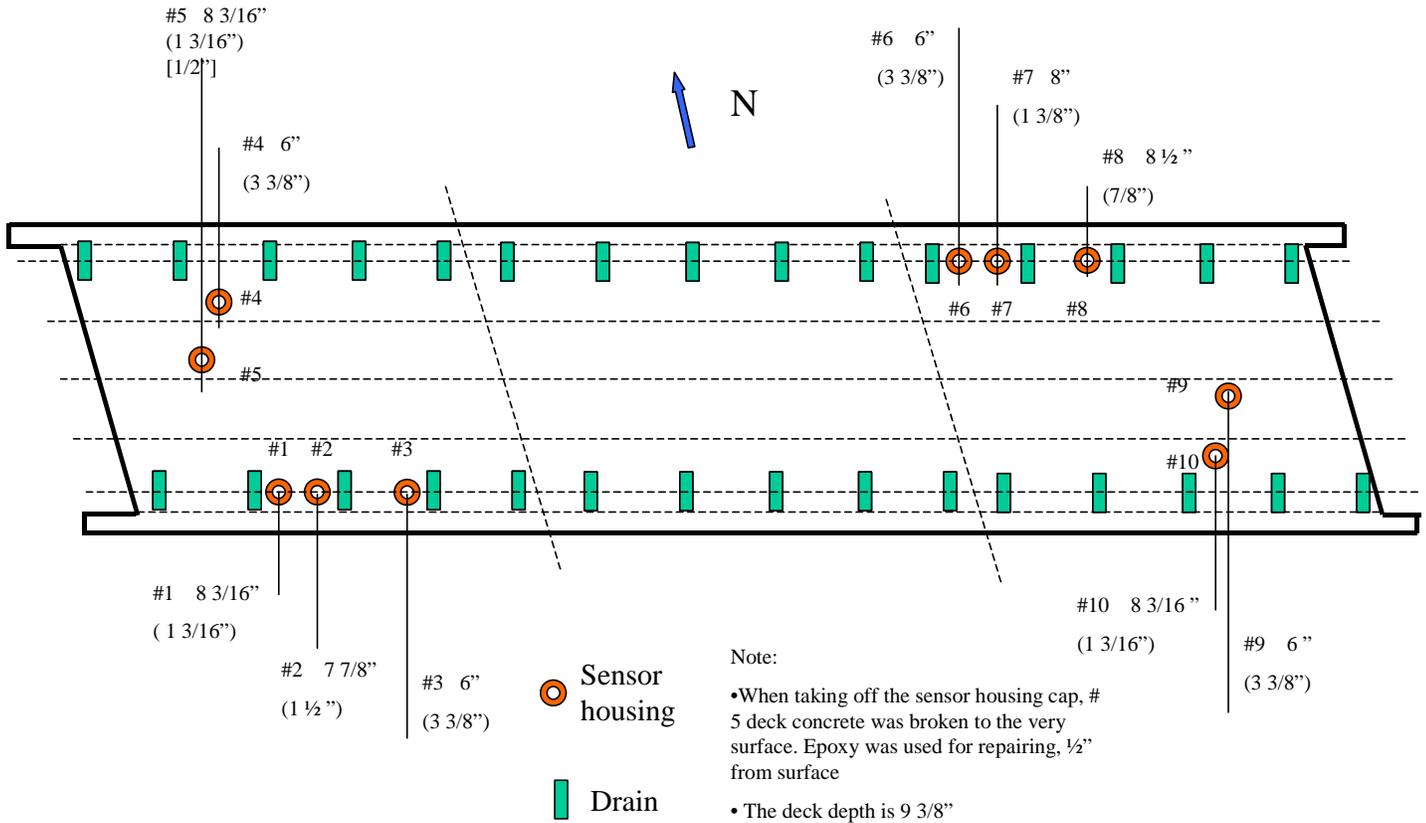
Depths of Sensor Housings Stainless Steel Bridge, A 6059

Figure 10.d. The depth of each sensor housing throat is shown for bridge number A6059.

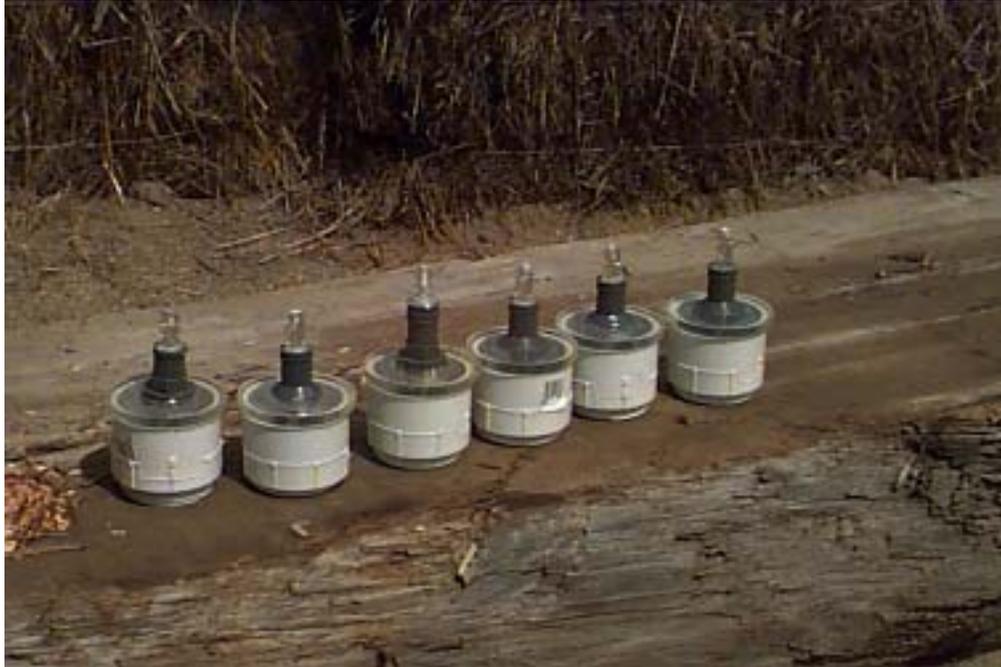
To reiterate, Missouri Department of Transportation employees placed the sensor housings into the twin bridges. Details regarding the installation (e.g., ambient conditions, type of concrete, deck work details, etc) must be obtained from MoDOT. It is envisioned that the sensor housings that were embedded are similar to those shown in Figure 11.

Figure 11. The length of the sensor housing's throat may be modified.

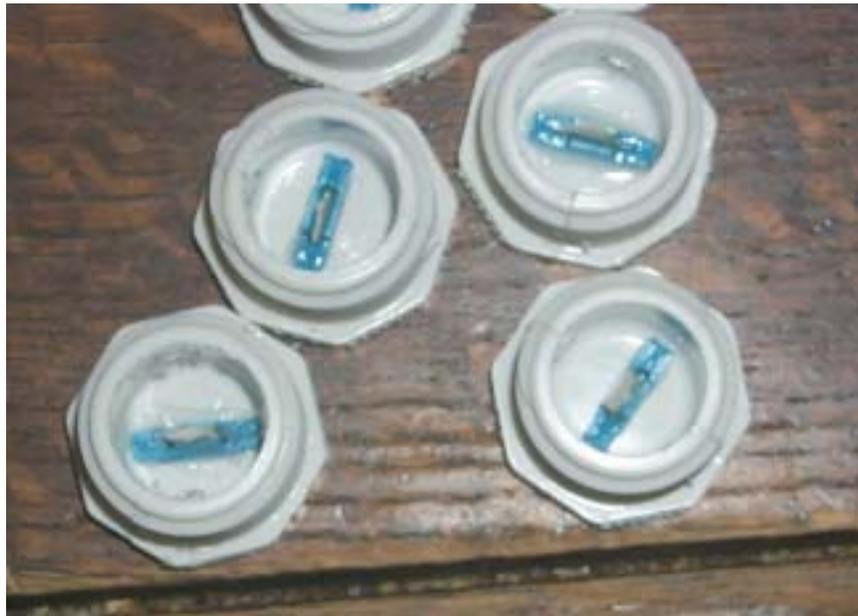
As previously mentioned, the sensor housings were embedded into the twin bridge decks in 2000. The actual sensing "inserts" were designed, fabricated and tested during the summer-early Fall of 2001. As opposed to earlier efforts in fiber optic chloride sensing within concrete structures, the sensors used in these bridges had a true analog varying chloride measurement insert, shown in Figure 12.

Figure 12. Close-up view of the chloride sensing insert.

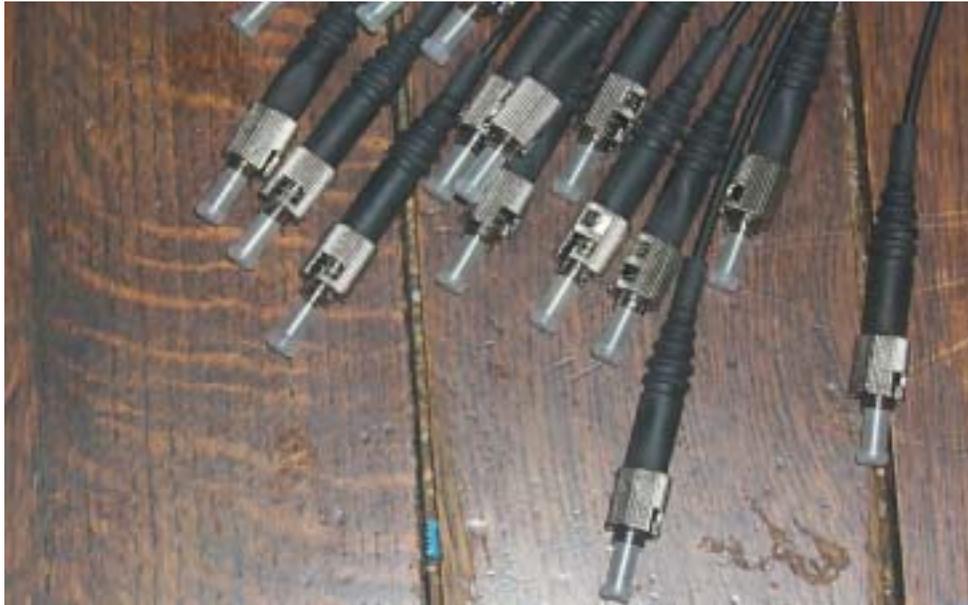
Polymer optical fibers, 960 μm diameter, each being 25cm in length had ST fiber optic connectors placed onto their ends (as shown in Figure 13) and served as the ingress/egress to the chloride sensing insert. These fibers were shown in a laboratory setting to have excellent mechanical properties while providing ample light to the sensor insert for an adequate signal-to-noise ratio for chloride sensing.

Figure 13. Multimode 960mm diameter polymer optical fiber with ST connectors is used.

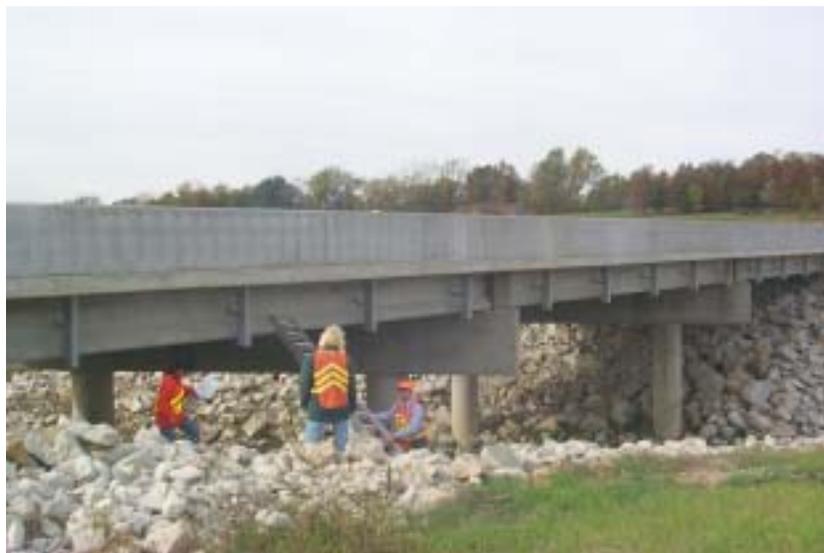
Figure 14. Ladders provided access to the sensor housings.

Installation of the chloride sensor inserts was a relatively easy process since access to the housings was achieved via a ladder.

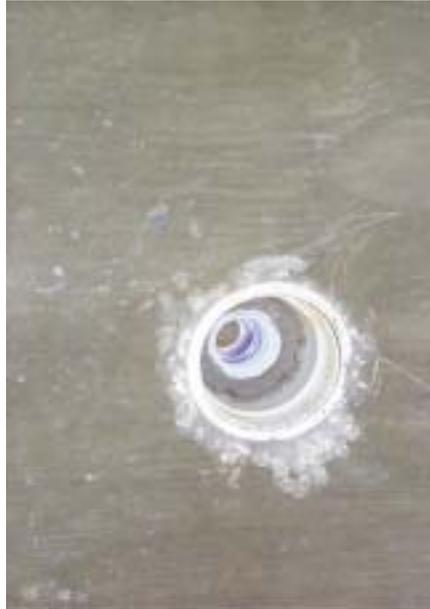
In most cases, the embedded sensor housing was in a nearly pristine condition (see Figure 15) thereby providing an excellent conduit for the waterborne chloride ions to reach the sensing insert.

Figure 15. View of an exposed sensor housing located in bridge#1.

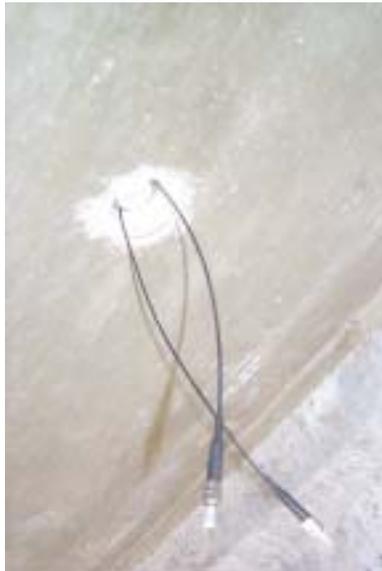
The view of a sensor insert that has been installed into the sensor housing within the concrete deck of Bridge #1 is shown in Figure 16. The fiber optic leads were then coiled and placed into the housing with a PVC cap screwed onto the housing. This leaves an embedded sensor that is relatively unobtrusive and hopefully not of "interest" to anyone who may wander under either bridge.

Figure 16. A modular design allows for the sensor insert to be simply screwed into the housing.

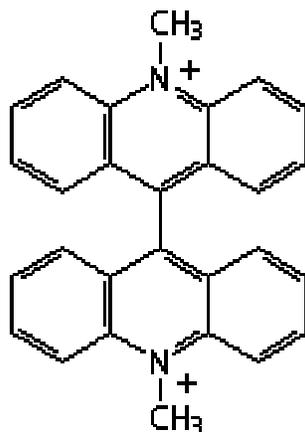
The two types of chloride sensing chemicals used lie within the fluorescent dye family: Lucigenin; 9,9'-Bis(N-methylacridinium nitrate), $C_{28}H_{22}N_4O_6$, MW 510.51 (chemical diagram shown in Figure 17); and, N-(3-sulfopropyl)acridinium, inner salt (SPA), $C_{16}H_{15}NO_3S$, MW 301.36 (chemical diagram shown in Figure 18). These two reagents provide two different sensitivity levels for minimum activation chloride ion concentration.

Figure 17. Chemical "schematic" diagram of Lucigenin; 9,9'-Bis(N-methylacridinium nitrate).

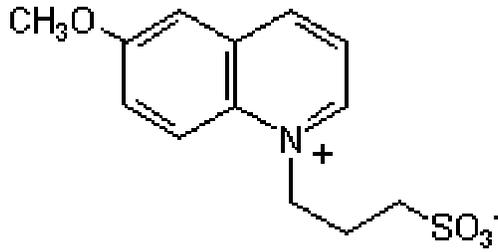
Figure 18. Chemical "schematic" diagram of N-(3-sulfopropyl)acridinium, inner salt (SPA).

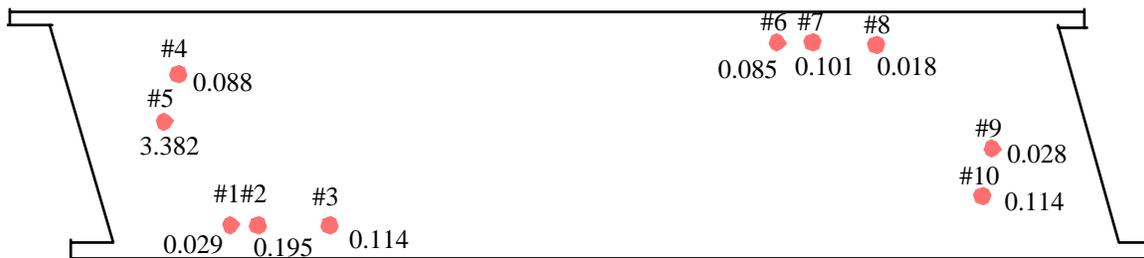
Baseline Power Readings for Sensors Embedded into Bridge A6059

Baseline readings taken during the sensor insert installation were based strictly on intensity. A FOTEC optical source ($\lambda=822\text{nm}$) and an associated Si photo detector power meter (ST connector adaptor) were connected to the input and output fiber optic leads. The received intensity for identical launched power configurations were recorded. While the actual chloride concentration levels are measured spectroscopically, the spectrometer must have a minimum amount of received optical power. The power transmitted through the twenty (20) installed sensors varied from $0.018\mu\text{W}$ (min) to $2.881\mu\text{W}$ (max). A diagram of each bridge's sensor baseline transmitted power readings is presented as Figure 19a and b. The detection process requires a signal level of at least $0.004\mu\text{W}$, thus each sensor passed the minimum power requirements.

Figure 19.a. Baseline power readings for sensors within bridge A6059.

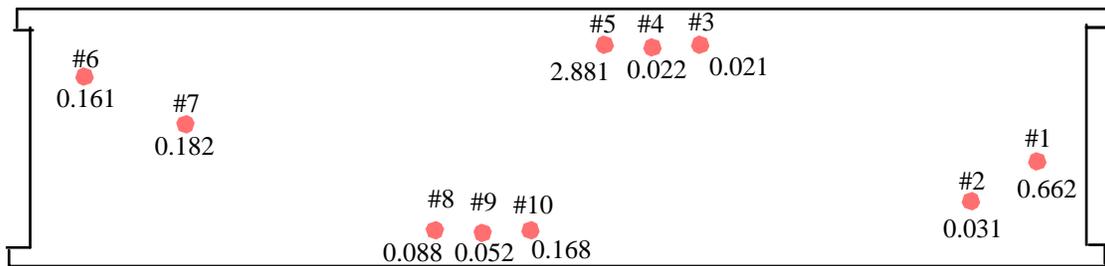
Baseline Power Readings for Sensors Embedded into Bridge A6060

Figure 19.b. Baseline power readings for sensors within bridge A6060.
